December 29, 2017

**Efflorescence Potential of Ceramic Tile Grout
CTLGroup Project No. 391642**

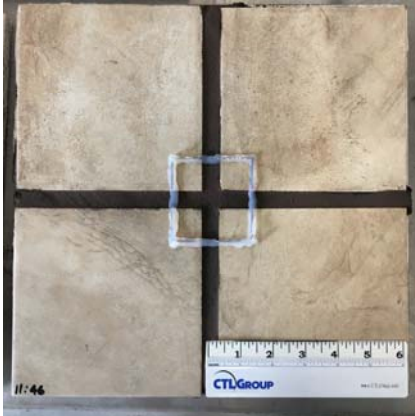
Figure 1. Grout sample tile with silicone caulk dam around center

As requested, a 2-inch square silicone caulk dam was applied around the center of a grout line as shown in Figure 1. After the silicone had hardened, 2 ml. of deionized water were applied to the specimens at the specified age in the center of the tile within the silicone dam as shown in Figure 2. The water was allowed to pond over the specimens, and any presence of efflorescence was assessed after 24 hours.

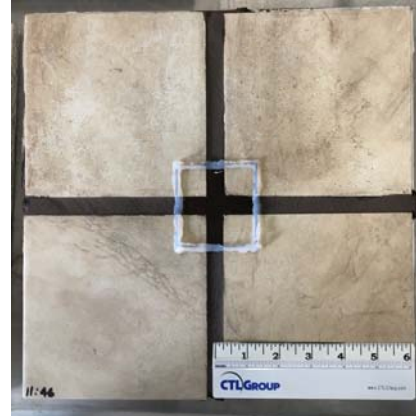
Figure 2. Grout sample specimen after 2 ml of deionized water have been applied in the center of grout lines

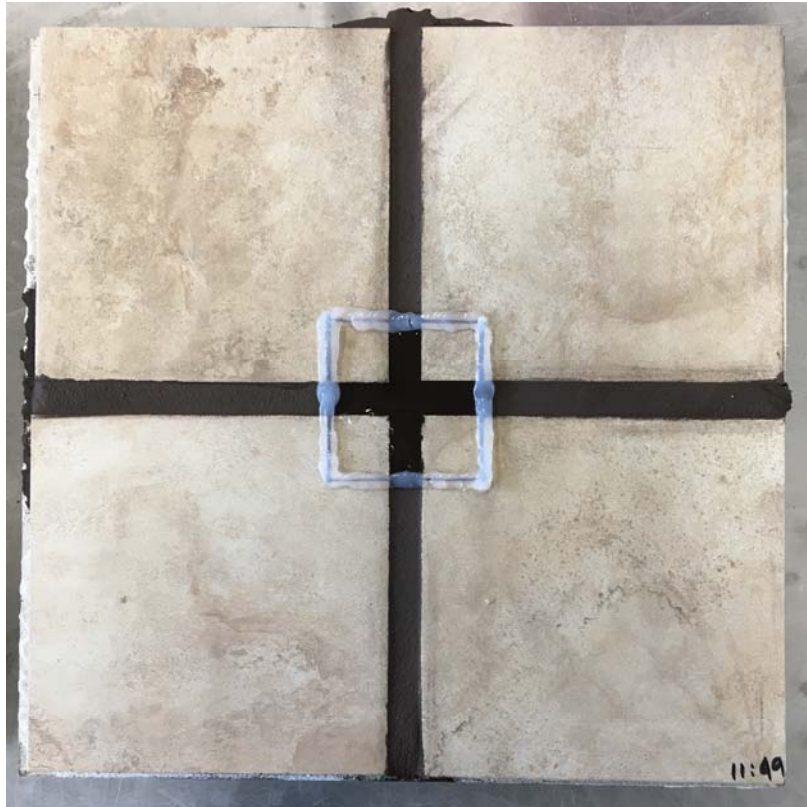
Figure A-1. Hydroment® Vivid™ - Bostik in Flash Walnut grout sample at 3 days of curing during efflorescence emittance test

Efflorescence was observed on all the specimens prepared with Hydroment® Vivid™ - Bostik (Flash Walnut) at all test ages. Photos of the test results for the submitted sanded grout are presented in APPENDIX A.

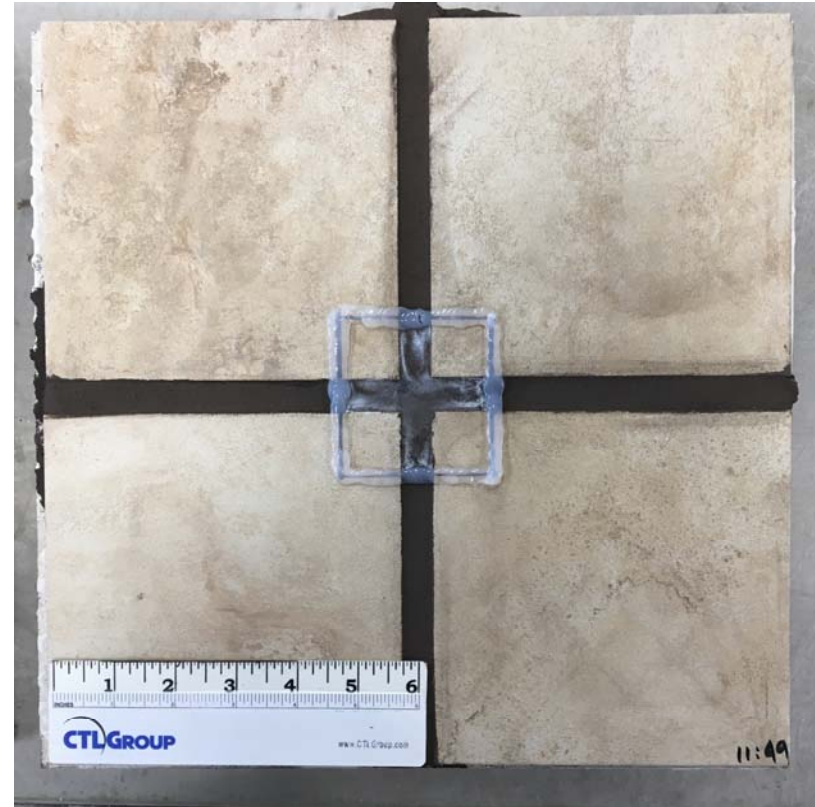
Figure A-2. Hydroment® Vivid™ - Bostik in Flash Walnut grout sample at 3 days of curing after efflorescence emittance test

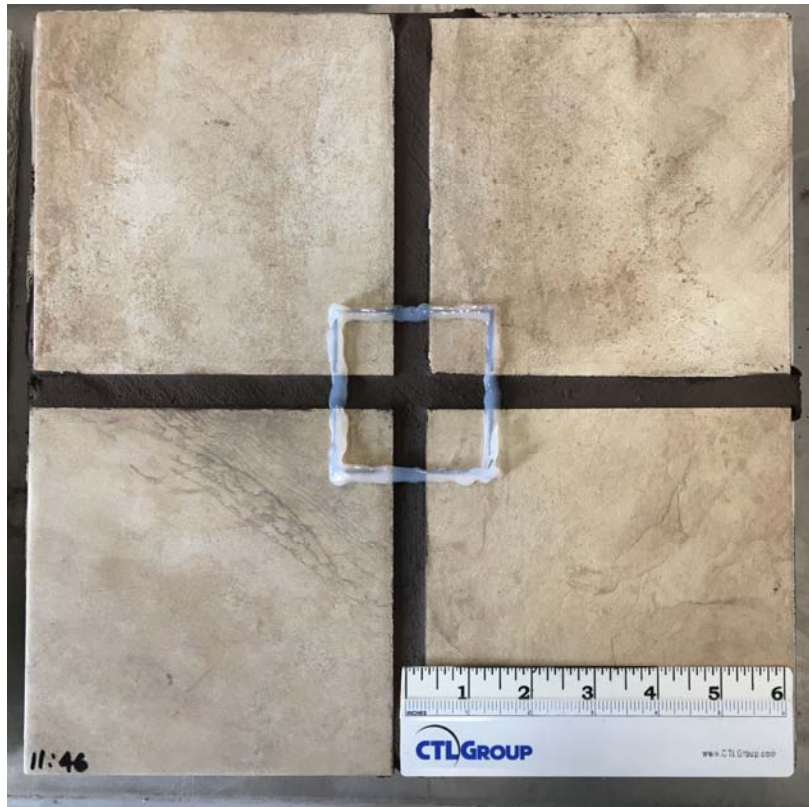
Figure B-1. Hydroment® Vivid™ - Bostik in Flash Walnut grout sample at 7 days of curing before efflorescence emittance test

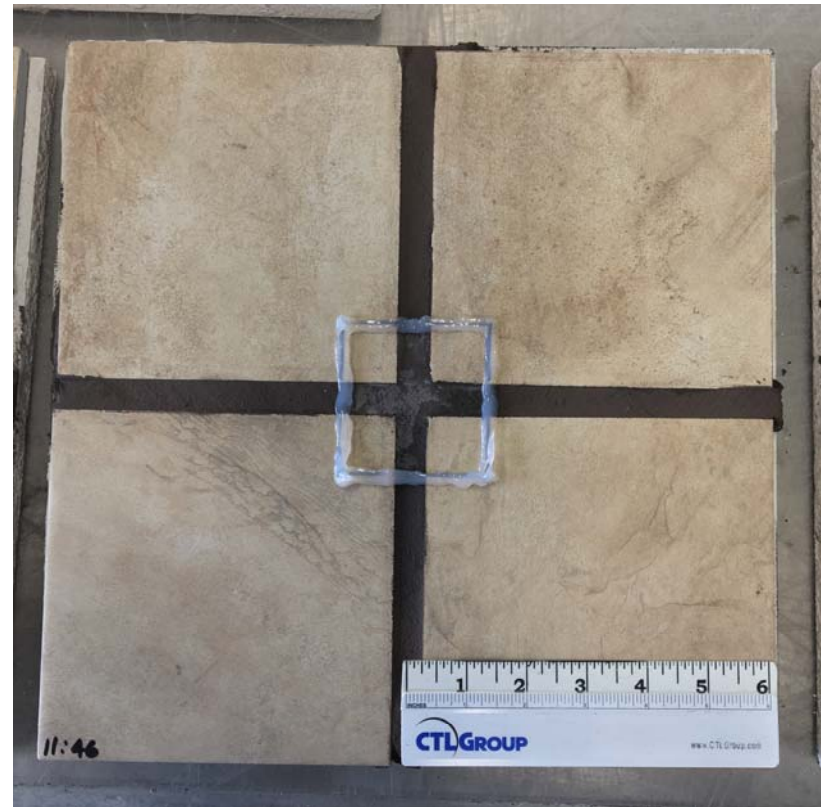
Figure B-2. Hydroment® Vivid™ - Bostik in Flash Walnut grout sample at 7 days of curing after efflorescence emittance test

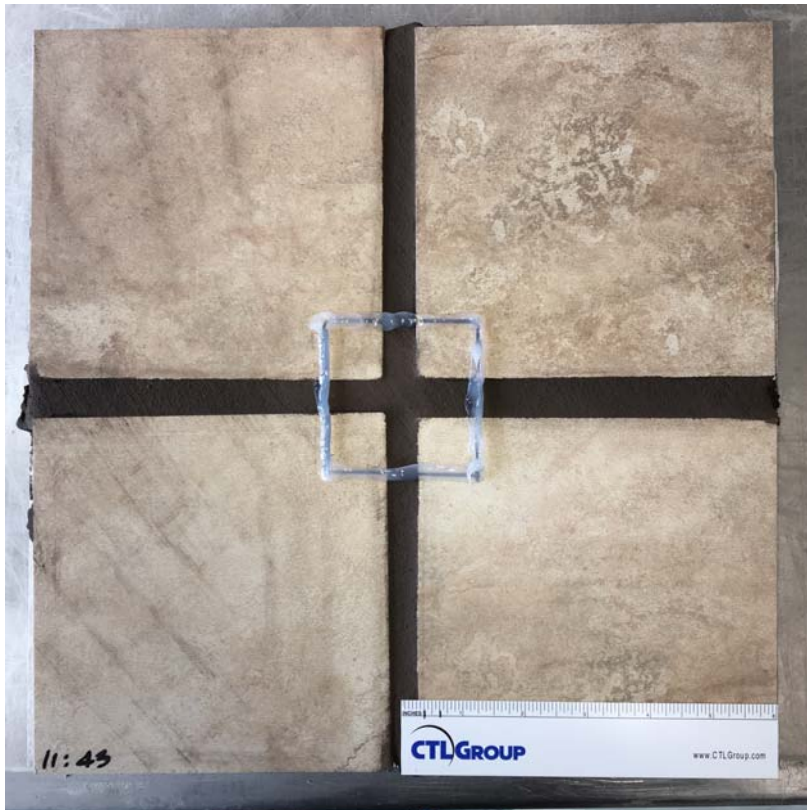
Figure C-1. Hydroment® Vivid™ - Bostik in Flash Walnut grout sample at 28 days of curing before efflorescence emittance test

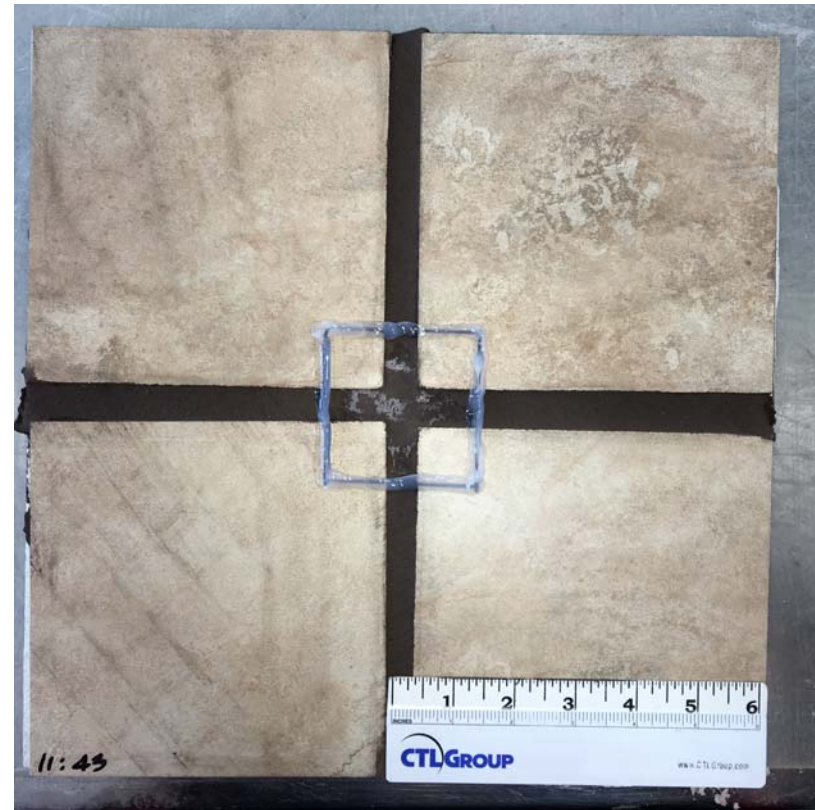
Figure C-2. Hydroment® Vivid™ - Bostik in Flash Walnut grout sample at 28 days of curing after efflorescence emittance test
